Radio Design 101 Epilogue 2 – Debugging and Troubleshooting

This second follow-up (epilogue) to the Radio Design 101 series offers tips on how to troubleshoot electronic circuits. The problems found in Epilogue 1 are addressed and the radio performance is improved - but the main focus is on general troubleshooting techniques. A preview look at emerging Q-enhanced filter technology is also provided, as is an example of applying the troubleshooting techniques to car repair to illustrate that the techniques are useful in general problem-solving.

Radio Design 101

Debugging / Troubleshooting

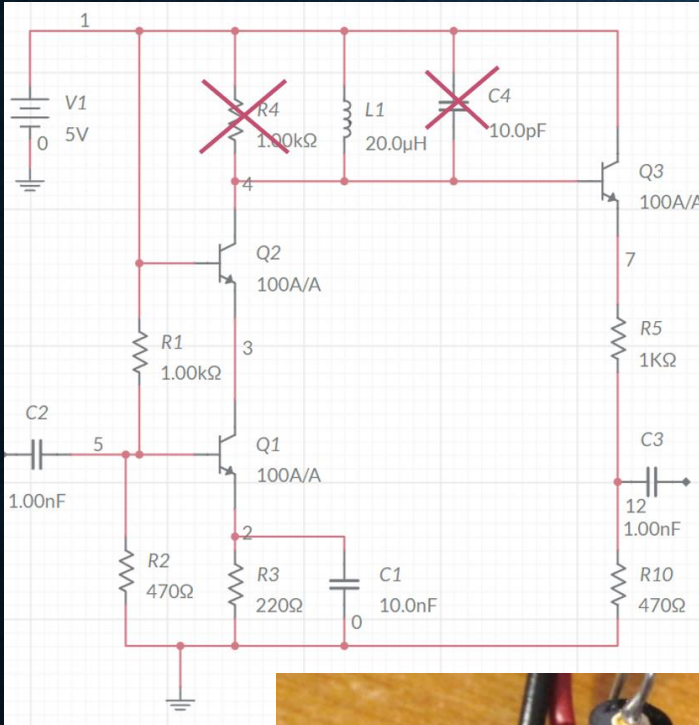
Troubleshooting (basic checks)

- What changes were made since last time it worked? (de-soldering in IF amp output stage)
- Verified visually and with Ohm meter that connections were OK
- Verified DC bias voltages at V_{cc} , and at Q2 and Q3 base and emitter
- Probed signal at IF amp output with receiver tuned to a strong station
- Noticed it's oscillating around 6 MHz !

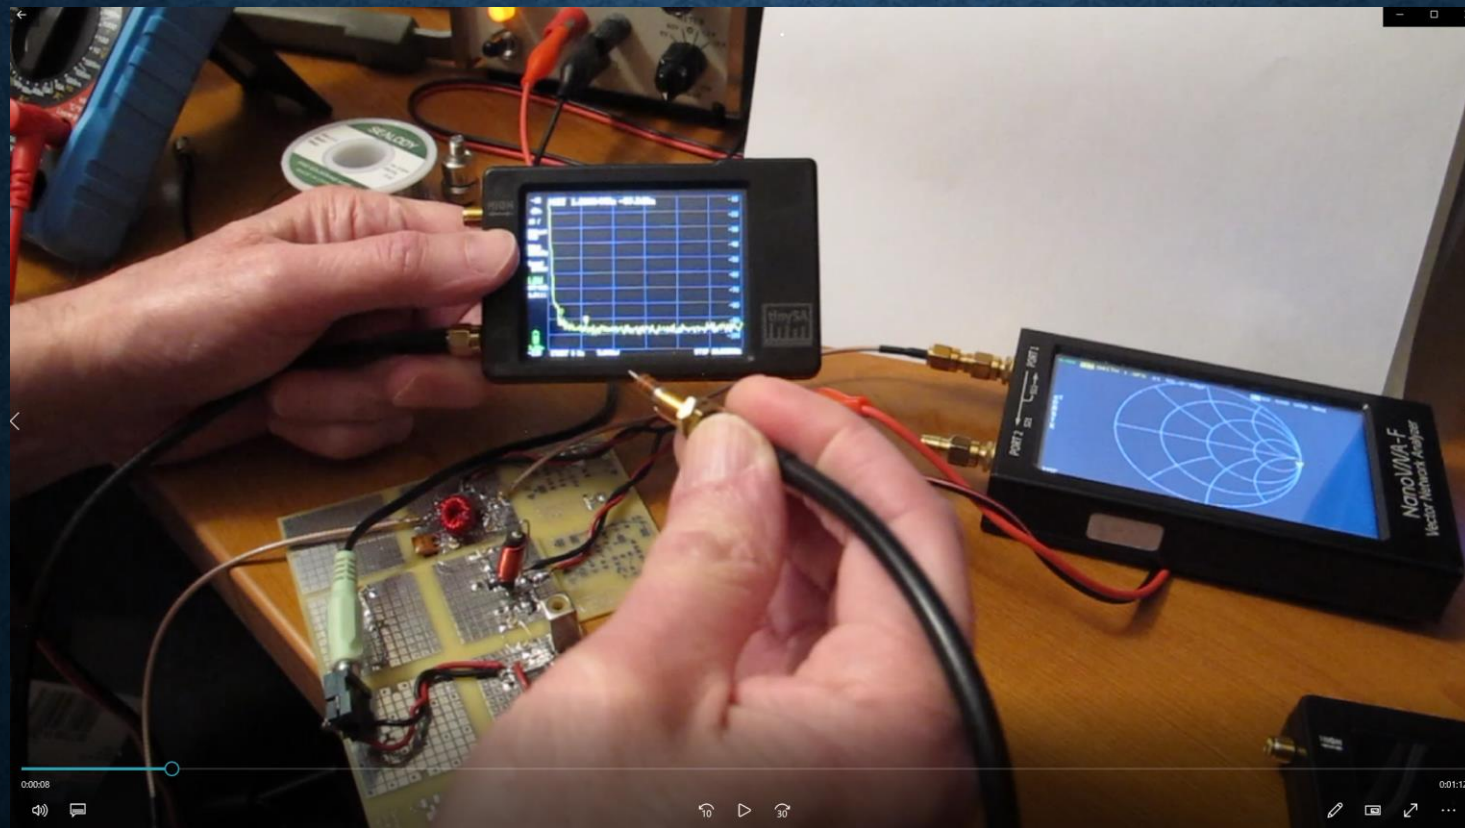
Troubleshooting (RF probing)

WARNING: Only for low voltage, low-power circuits and with a DC block (and suitable attenuation)!

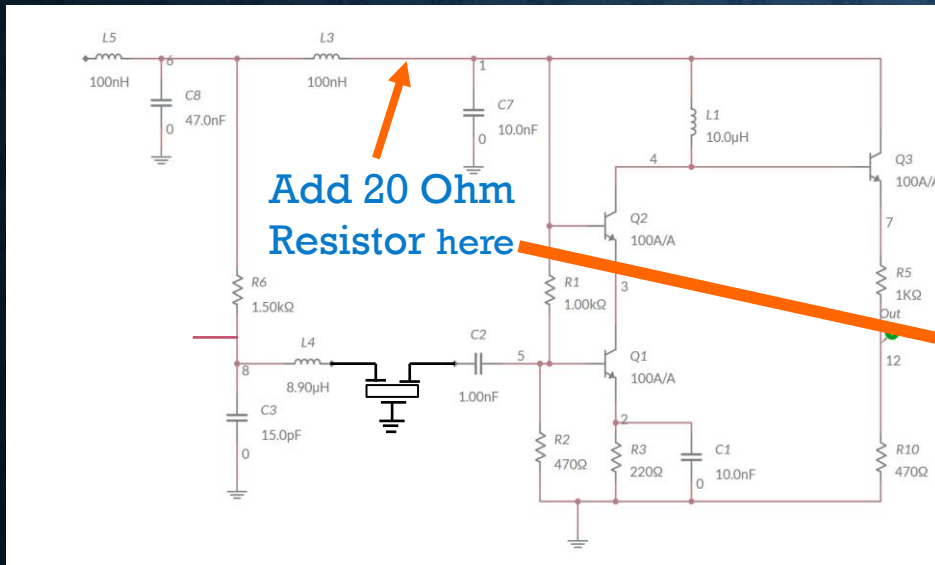
Testing Theories

- Proposed solutions included adding series R in supply lead to “de-Q” resonance between C7, L3.
- Added 20 Ohm series R with supply feed and got excellent, stable reception 😊

NOTE: This was standard practice in older designs. Modern books / papers / PCB layout guidelines surrounding bypass cap issues fall under the term “Power Integrity”

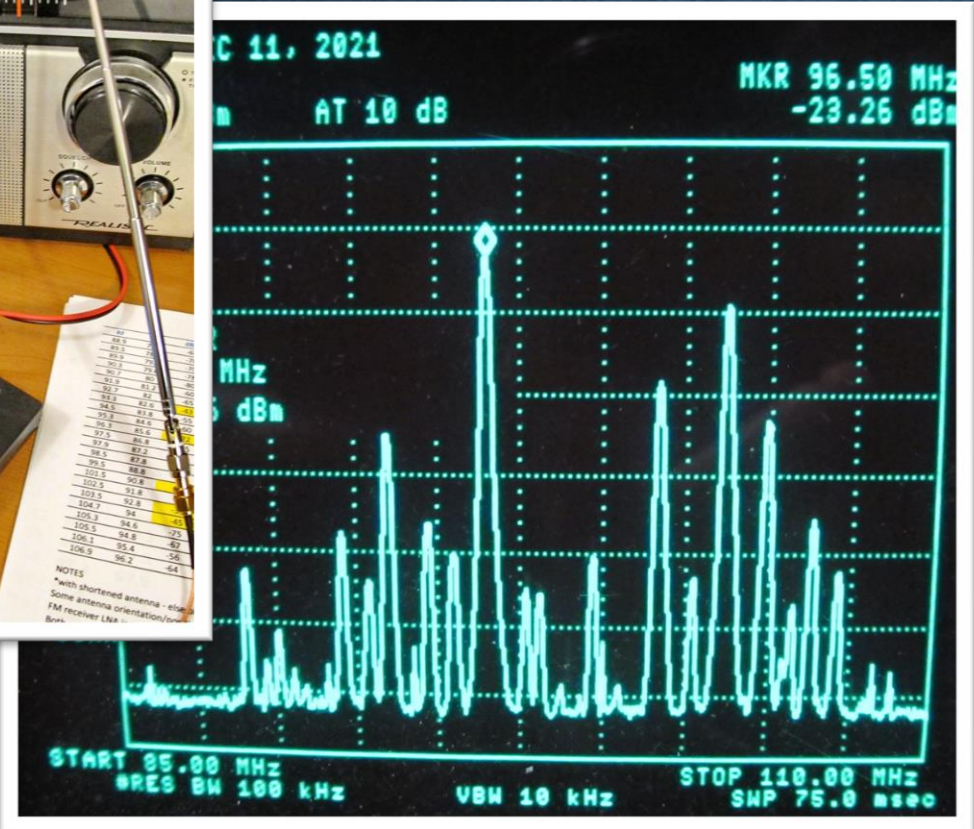
Performance Now

RF	LO	dBm	FMrx	FMrxFixed	VR120	VR120atten	Old Radio
88.9	78.2	-65				yes	yes
89.5	78.8	-78			yes		yes
89.9	79.2	-70	quiet	quiet	yes	yes	yes
90.3	79.6	-78		quiet		yes	yes
90.7	80	-80					yes
91.9	81.2	-60	quiet	good	yes	yes	yes
92.7	82	-65		good		yes	yes
93.3	82.6	-43	excellent	excellent	yes	yes	yes
94.5	83.8	-55	quiet	good	yes	yes	yes
95.3	84.6	-60	quiet	good	yes	yes	yes
96.3	85.6	-22	excellent	excellent	yes	yes	yes
97.5	86.8	-65		good		yes	yes
97.9	87.2	-67	quiet	quiet	yes	yes	yes
98.5	87.8	-80					?
99.5	88.8	-61	?	excellent*		yes	yes
101.5	90.8	-40	excellent	excellent	yes	yes	yes
102.5	91.8	-62					yes
103.5	92.8	-30	excellent	excellent	yes	yes	yes
104.7	94	-45	good	excellent	yes	yes	yes
105.3	94.6	-75					yes
105.5	94.8	-67			yes	yes	yes
106.1	95.4	-56		very quiet	yes	yes	yes
106.9	96.2	-64			yes	yes	yes

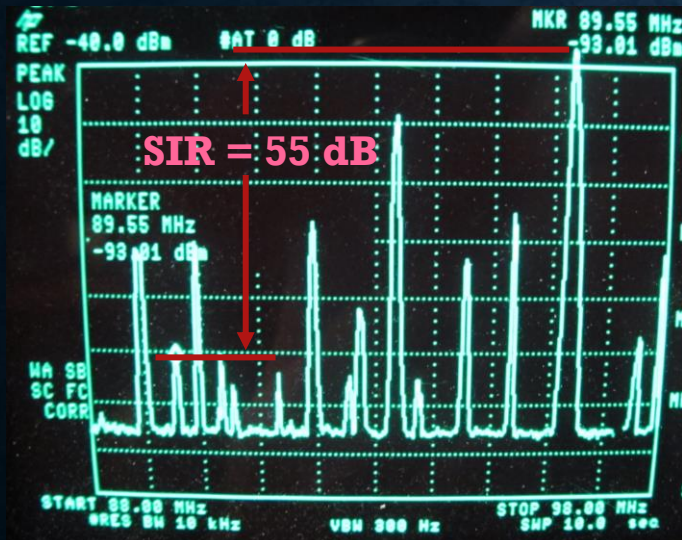
Signals from Antenna

Bottom end of Band
(88 to 98 MHz)

Spectrum analyzer noise
floor of -104 dBm (30 dB NF)

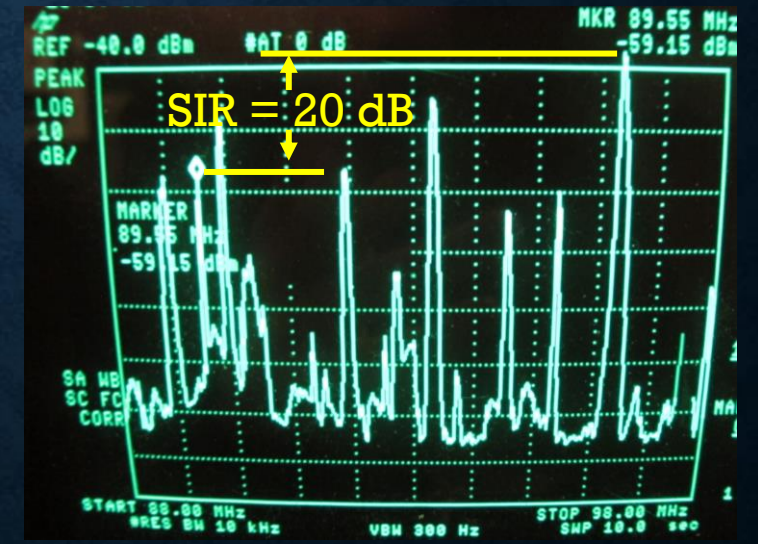
Output from Q-enhanced LNA

RF filtering tuned to 89.5 MHz

Q enhanced to 500 => 200 kHz
bandwidth (at RF, before mixer !)
